#### PROJECT RED HORSE

1 SEPTEMBER 1969

### HQ PACAF Directorate, Tactical Evaluation CHECO Division

Prepared by:
LT DEREK H. WILLARD
Project CHECO 7th AF, DOAC

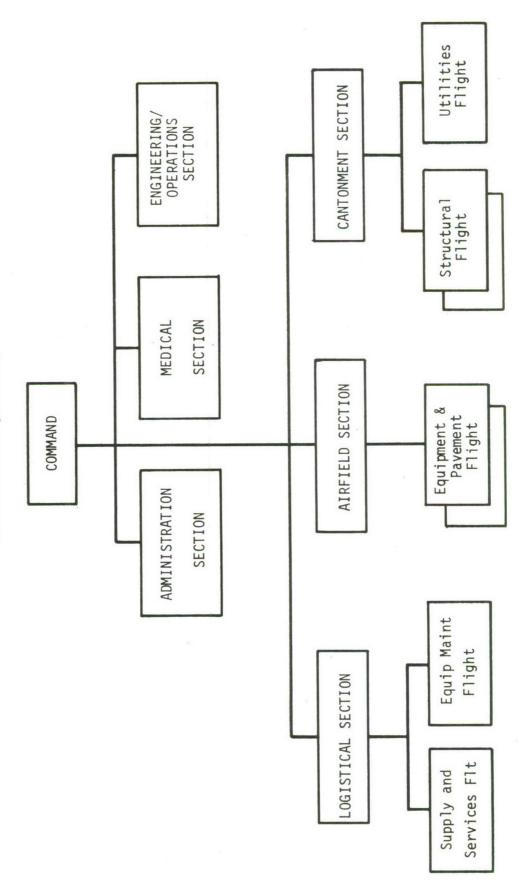
FIGURE 2

# ORGANIZATIONAL CHART

Civil Engineering Squadron (Heavy Repair) (Standard Configuration)

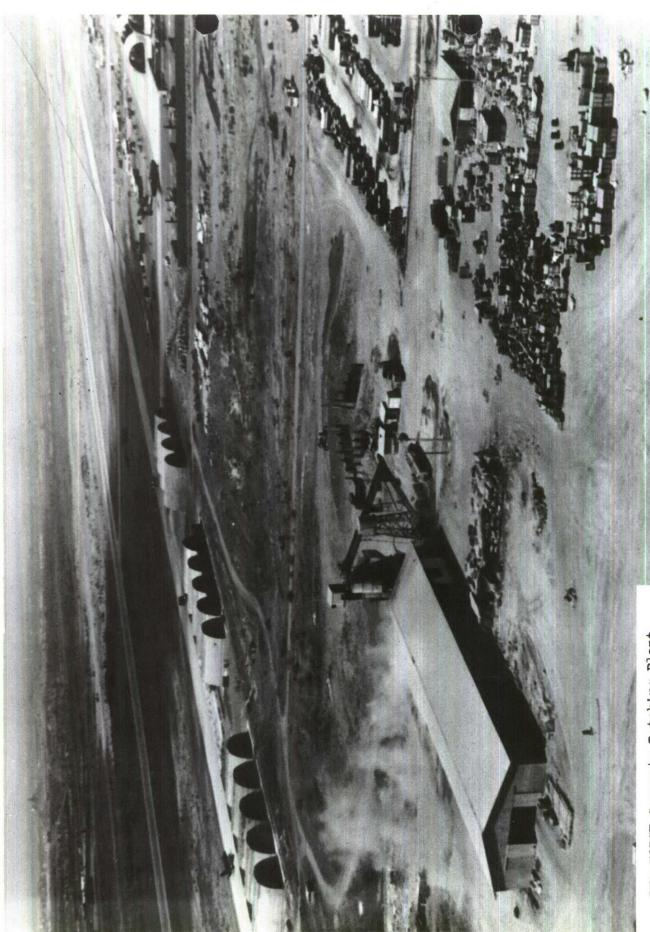
RED HORSE Concrete Batching Plant
Figure 5
UNCLASSIFIED

In the spring of 1967, the 554th became the first Air Force Civil Engineering unit in Vietnam to own and operate a concrete batch plant. (Fig. 5.)

This paving capability was still being used extensively at the time this report was written. For example, in March 1969, the 554th concrete batch plant produced 8,310 cubic yards of concrete. Most of this production was used for the construction of large, concrete dispersal hardstands (Fig. 6) and concrete covers for protective shelters. Of the 33 Military Construction Program (MCP) and O&M projects (dollar value 2.4 million) in progress during March 1969, the concrete shelter program was the largest. This project consisted of the construction of 61 concrete covered aircraft protective shelters. With the exception of 16, these were located on new, dispersed hardstands. Shelter

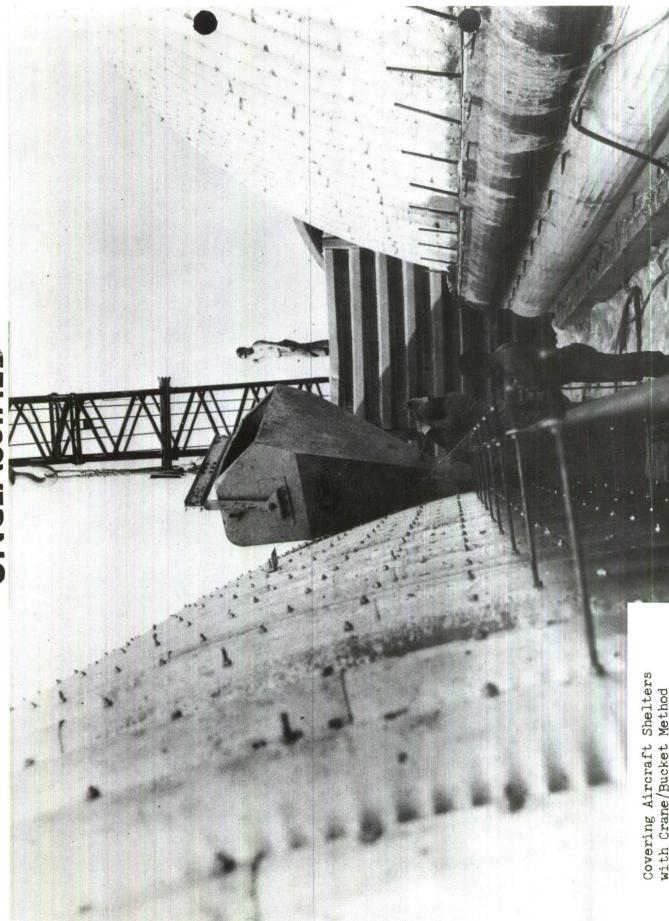
Covering Aircraft Shelters
with Crane/Bucket Method
Figure 9
Figure 9

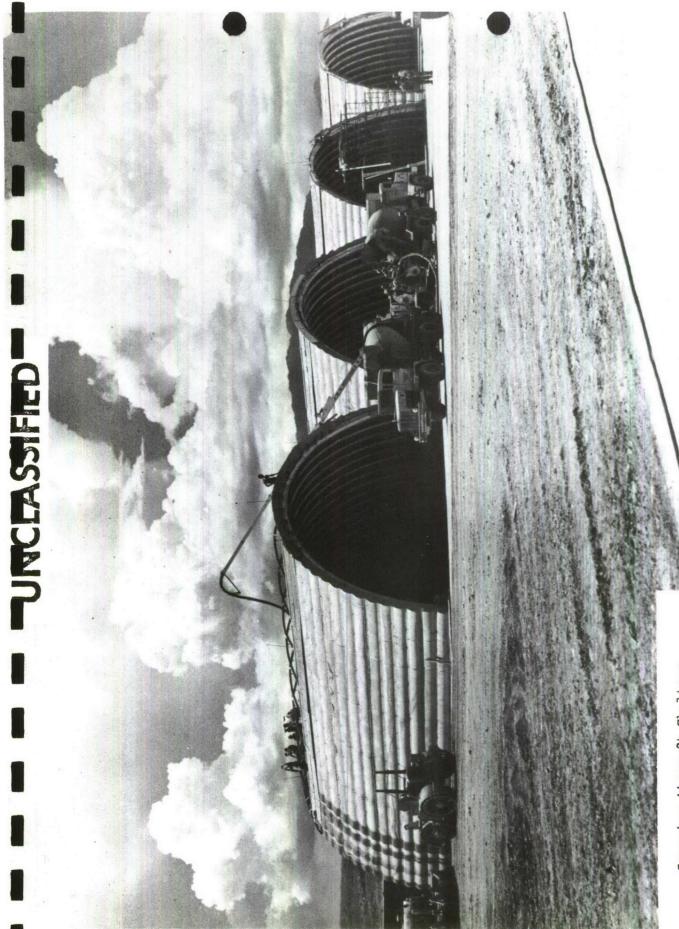
Covering Aircraft Shelters
with Squeeze Crete Pump
Figure 10
Figure 10

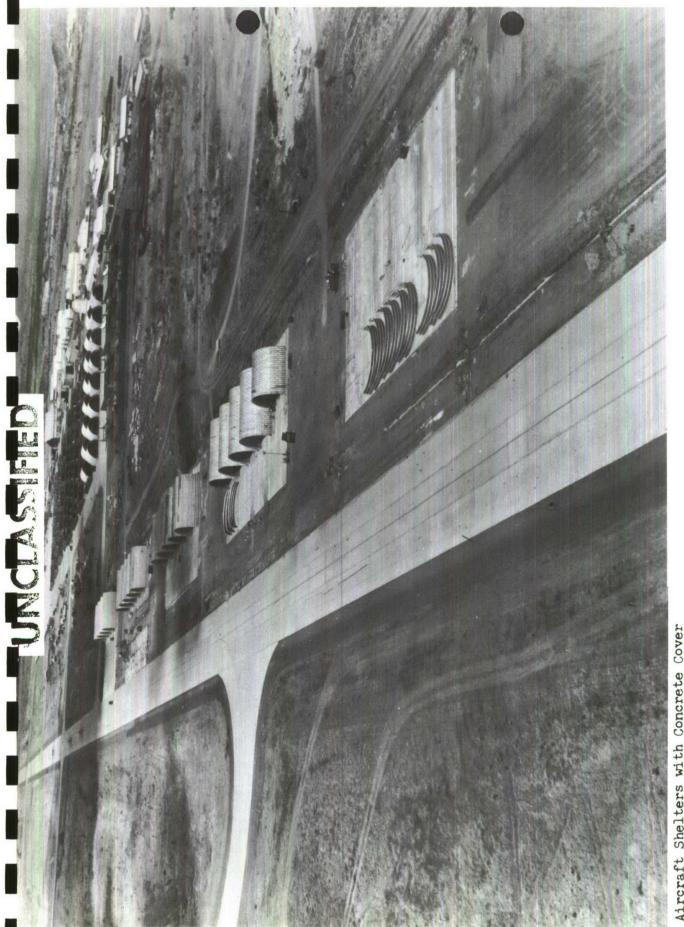
Aircraft Shelters with Concrete Cover Figure 11

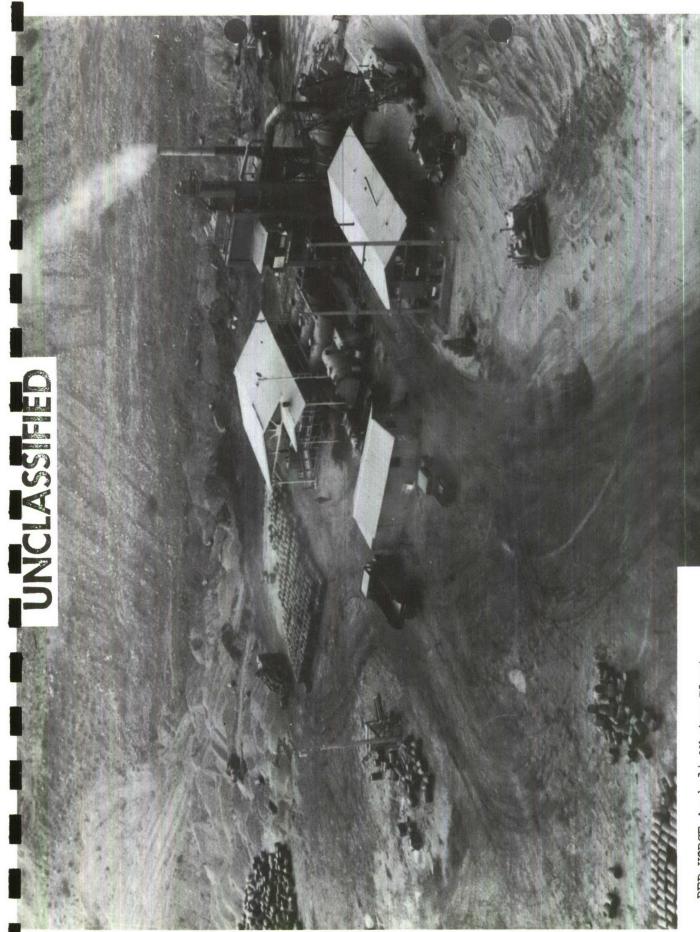
RED HORSE Asphalt Mixing Plant Figure 14
